## Item #13355288 - 2019 Rubble Master SC5700M Screen

- Features: Tier 4, Cummins QSL 6 Cylinder 97 kW 3.8 L Diesel Engine, Requires Diesel Exhaust Fluid, 3660 mm x 1525 mm Double Deck Screen, 32 in Wide Feed Conveyor, 46 in Wide Under Screen Conveyor, 25 in Wide Left Discharge Conveyor, 25 in Wide Right Discharge Conveyor, 46 in Wide End Discharge Conveyor, Cable Remote Control, 16 in Triple Grouser Track Shoes
- Meter Reading: 2,298 Hours
- Serial # : MSC5700M-2D-13-04
- Inspection Completed: 5/5/25

## Inspection Report

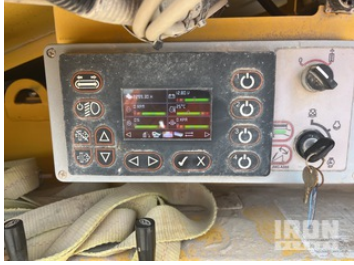
| Item | Assessment | Photo |
|---|---|---|
| Engine Controls | ★★★★☆ | |

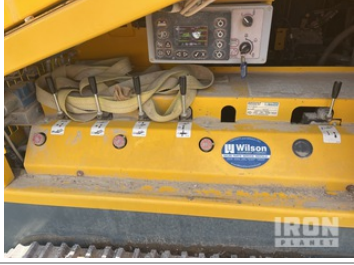
| Item | Assessment | Photo |
|---|---|---|
| Crusher/Screen Controls | ★★★★☆ | |

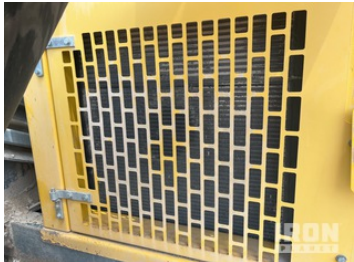
| Engine | | |
|---|---|---|
| Radiator | ★★★★☆ | |

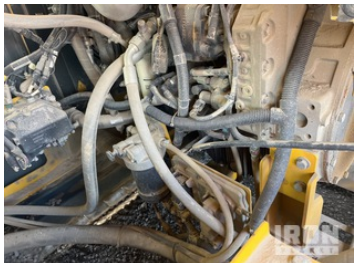
| Engine | | |
|---|---|---|
| Oil Leaks | No dripping leaks | |

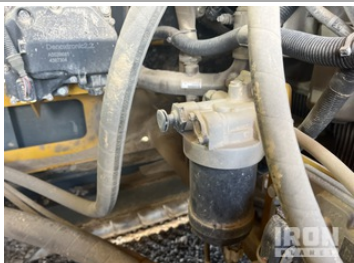
| Engine | | |
|---|---|---|
| Fuel Leaks | No dripping leaks | |

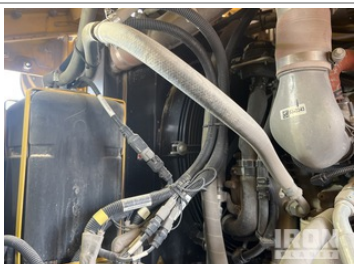
| Engine | | |
|---|---|---|
| Cooling System Leaks | No dripping leaks | |

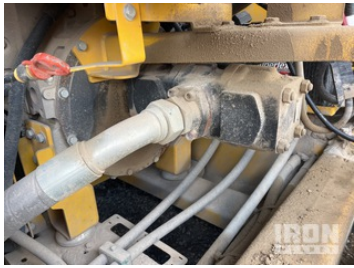
| Hydraulics | | |
|---|---|---|
| Pumps (Hydraulics) | ★★★★☆ | |

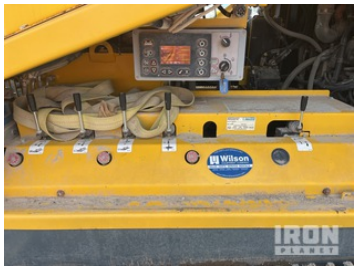
| Hydraulics | | |
|---|---|---|
| Valves | ★★★★☆ | |

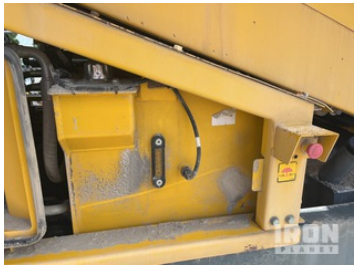
| Hydraulics | | |
|---|---|---|
| Hydraulic Tank | ★★★★☆ | |

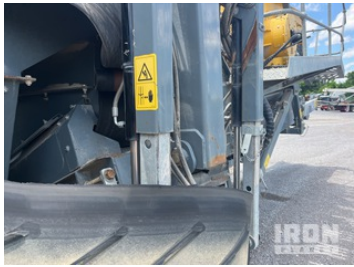
| Hydraulics | | |
|---|---|---|
| Conveyor Cylinders | ★★★★☆ | |

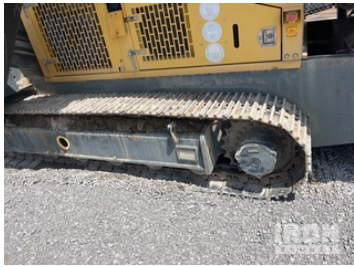
| Power Travel Drive System | ★★★★☆<br>Travels properly | |

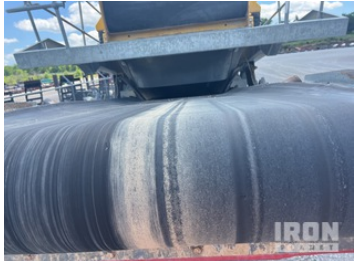
| Chassis | | |
|---|---|---|
| Discharge Conveyor Condition | ★★★★☆ | |

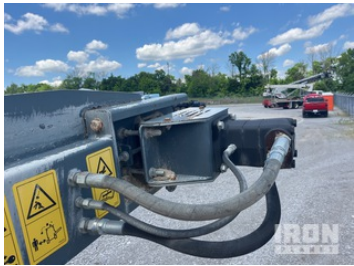
| Chassis | | |
|---|---|---|
| Discharge Conveyor Drive Motor | ★★★★☆<br>Not operationally checked | |

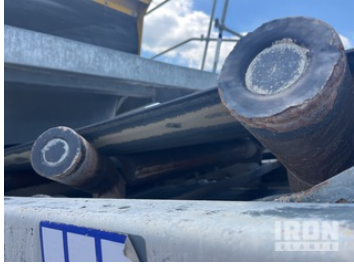
| Chassis | | |
|---|---|---|
| Discharge Conveyor Rollers | ★★★★☆ | |

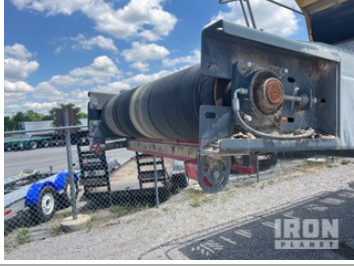
| Chassis | | |
|---|---|---|
| Discharge Conveyor Head and Tail Pulley | ★★★★☆ | |

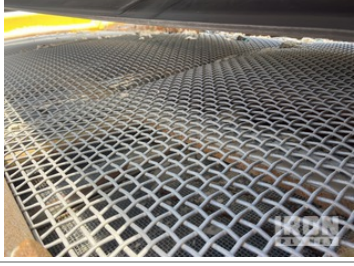
| Chassis | | |
|---|---|---|
| Screen Deck | ★★★★☆<br>Number of decks: 2 | |

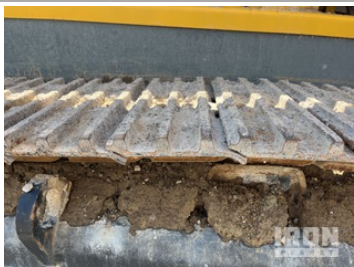
| Undercarriage | | |
|---|---|---|
| Left Grouser Height | 16 mm | |

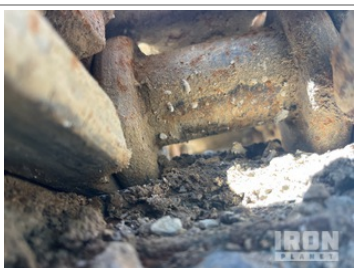
| Undercarriage | | |
|---|---|---|
| Left Track Bushings | Bushings have not been turned | |

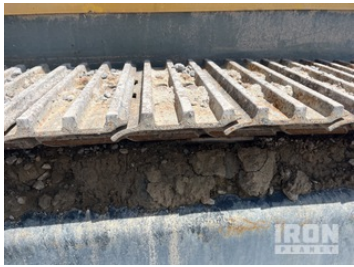
| Right Grouser Height | 16 mm | |

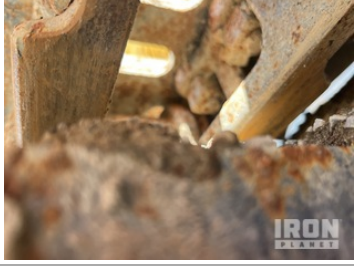
| Right Track Bushings | Bushings have not been turned | |
