## Item #13355288 - 2019 Rubble Master SC5700M Screen

- Features: Tier 4, Cummins QSL 6 Cylinder 97 kW 3.8 L Diesel Engine, Requires Diesel Exhaust Fluid, 3660 mm x 1525 mm Double Deck Screen, 32 in Wide Feed Conveyor, 46 in Wide Under Screen Conveyor, 25 in Wide Left Discharge Conveyor, 25 in Wide Right Discharge Conveyor, 46 in Wide End Discharge Conveyor, Cable Remote Control, 16 in Triple Grouser Track Shoes
- Meter Reading: 2,298 Hours
- Serial # : MSC5700M-2D-13-04
- Inspection Completed: 5/5/25

## Inspection Report

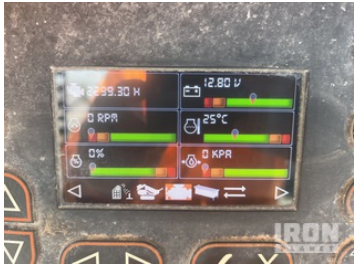
| Item | Assessment | Photo |
|---|---|---|
| Gauges | Operational | |

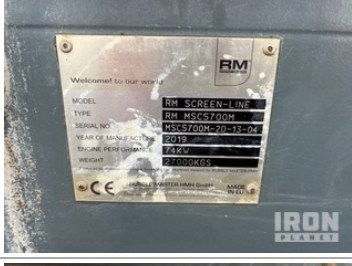
| General Appearance | | |
|---|---|---|
| Serial Number / VIN | MSC5700M-2D-13-04 | |

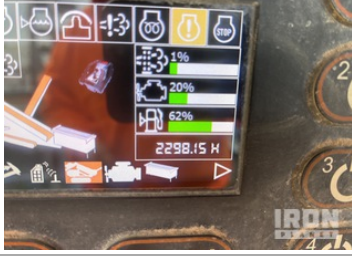
| General Appearance | | |
|---|---|---|
| Hour Meter / Odometer | 2298 hrs | |

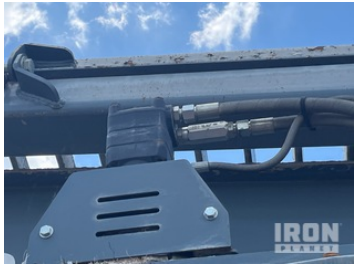
| Hydraulics | | |
|---|---|---|
| Hydraulic Motors | ★★★★☆ | |
